**HAZARDOUS WASTE GENERATOR/TRANSPORTER  
COMPLIANCE INSPECTION CHECKLIST**

Facility Name Ashland Specialty Chemical Company, Drew Division District Northeast

# **RCRA Compliance Evaluation Inspection Summary**

**Inspection Date: 2/28/02**

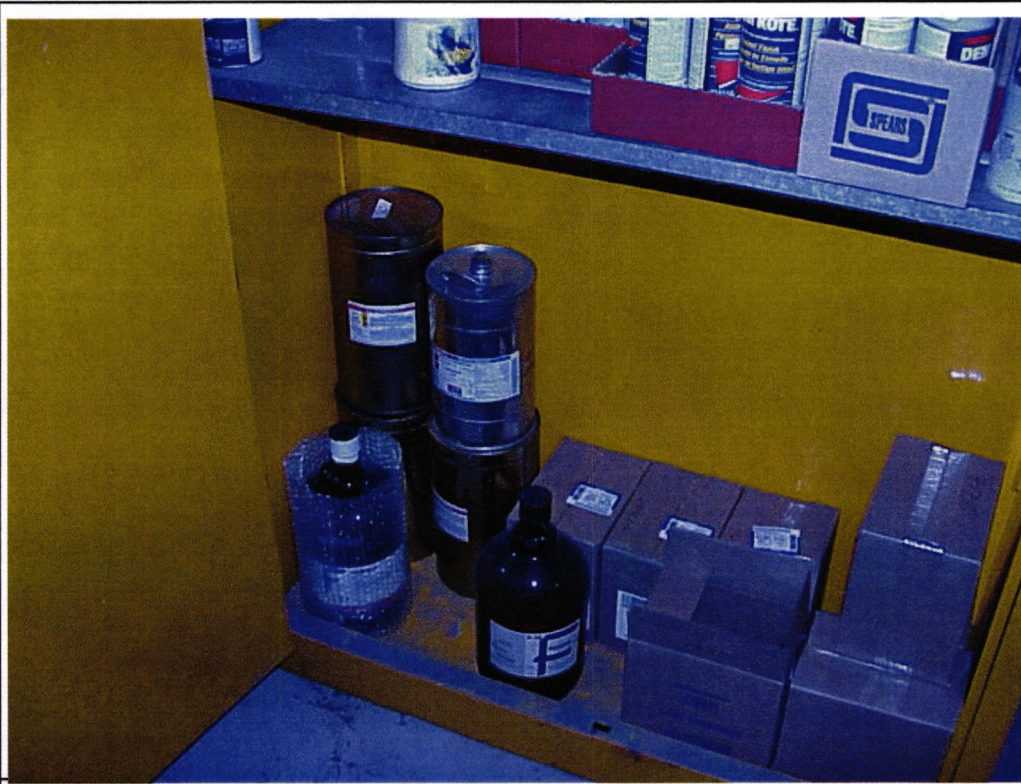
Picture No: 1

Comments: A view of the acetone, methanol, kerosene, and ethyl alcohol located in the flammable storage cabinet in the paint room at the facility.

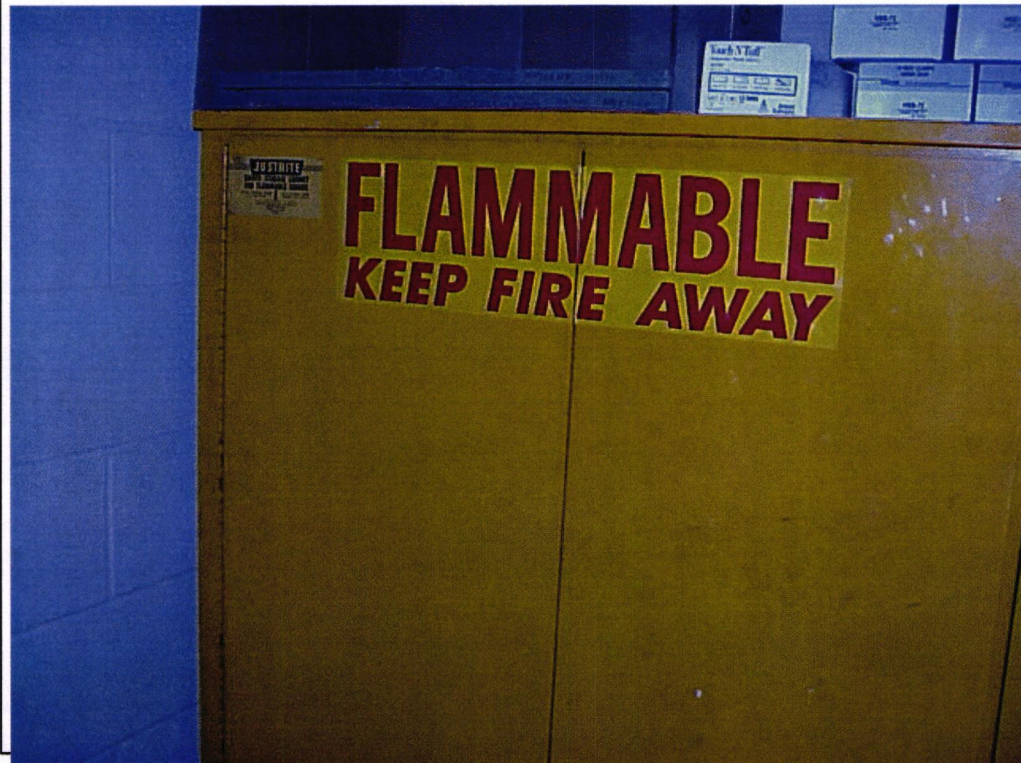
Picture No: 2

Comments: A view of the outside of the flammable storage cabinet shown in photo 1.

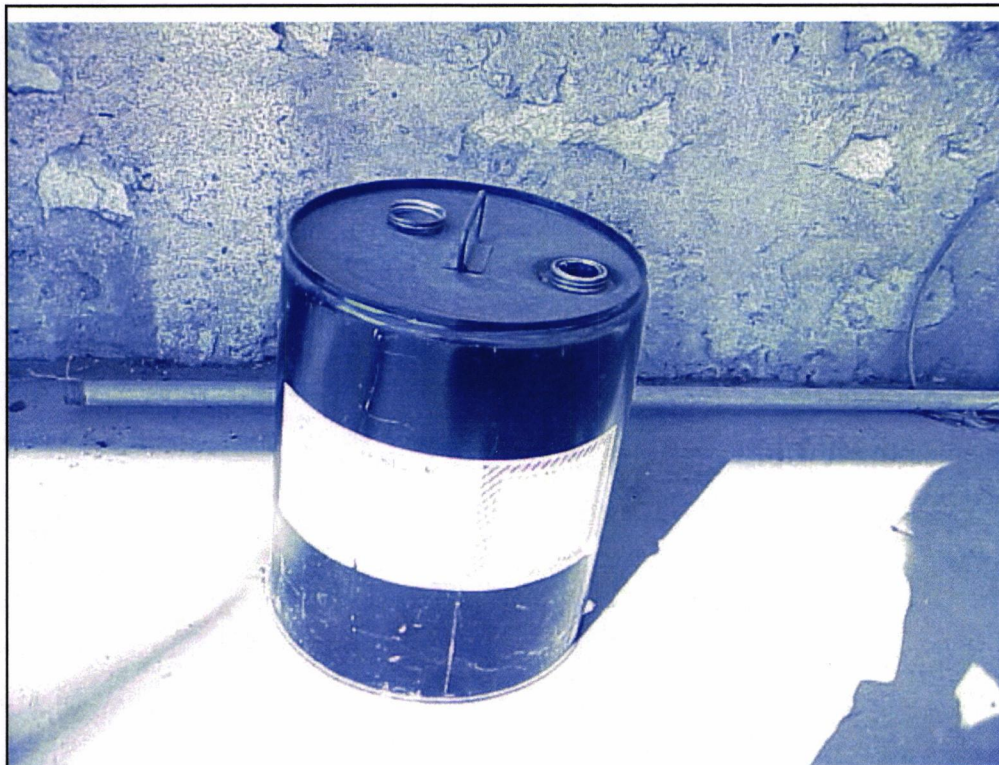
Picture No: 3

There was also one five-gallon can of DBE Cleaning Solvent located outdoors, under a roof, on the east side of the facility. This container had an open bung (which was closed during the inspection). The warning label on the container stated that this substance is flammable, and contains styrene monomer. Neither Mr. Christman nor Mr. Marckini were aware that this can was at the facility. Mr. Christman said that when he returned to the facility he was made aware of the cans presence and that he believed that they would be able to use this chemical for cleaning as well. He thought that it may have been left at the facility when a fiberglass tank located in the area of the can was removed about one and a half years ago.

Comments: A view of the 5-gallon can of DBE Cleaning solvent found outdoors on the east side of the building. Note the bung was off of this container, but was replaced during the inspection.

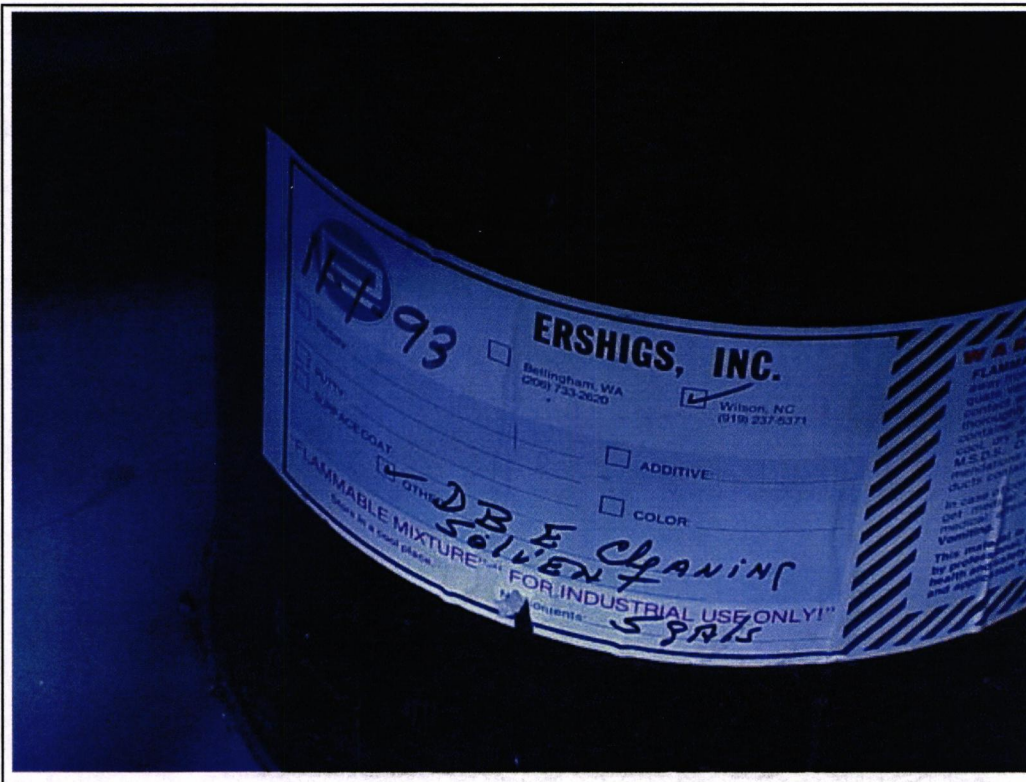
Picture No: 4

Comments: A closer view of the label on the container shown in photo 3.

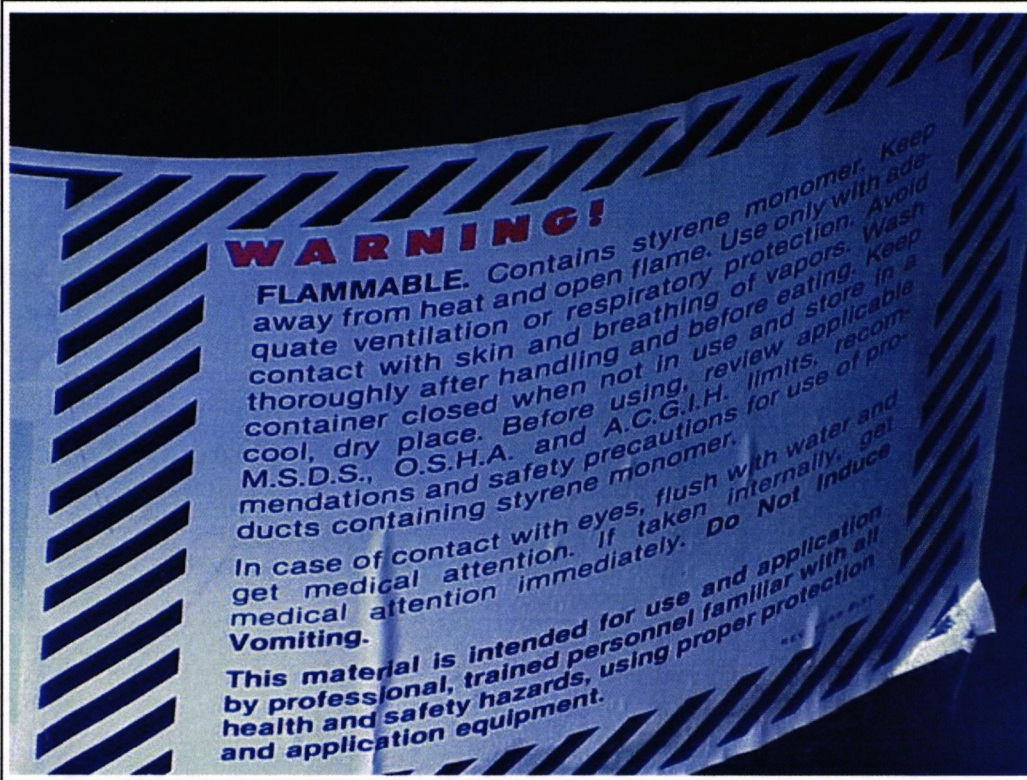
Picture No: 5

Comments: A closer view of the warning portion of the label on the container shown in photo 3.

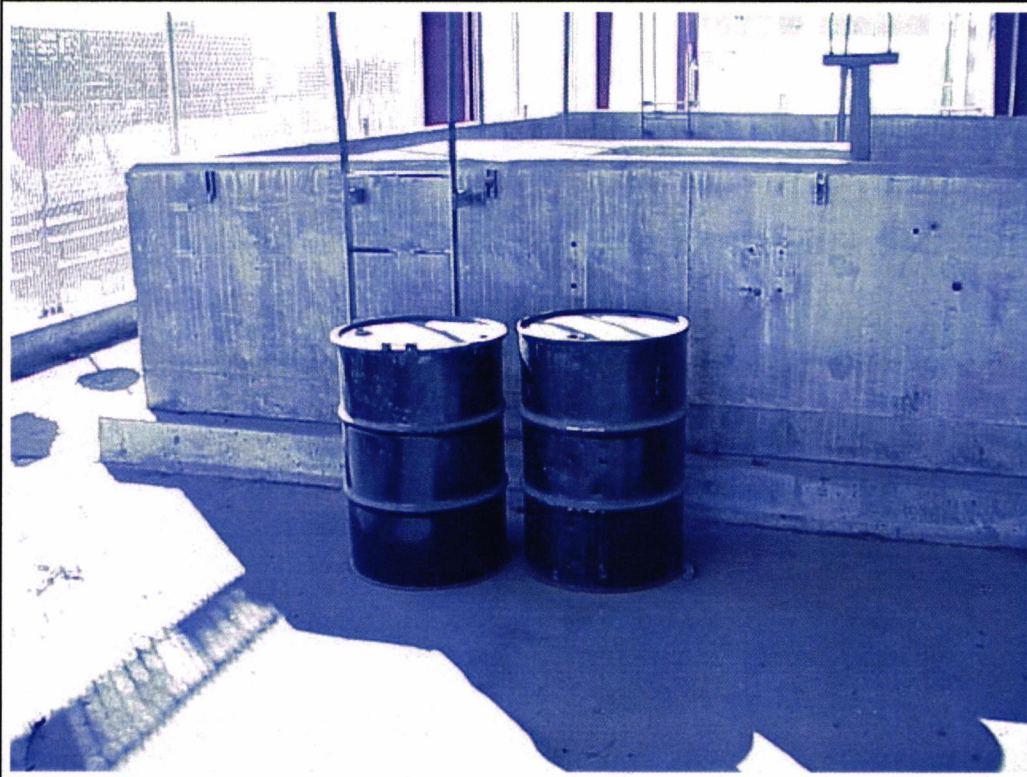
Picture No: 6

There were also two, 55-gallon drums located outdoors, under a roof, on the east side of the building. These drums were labeled "Olin-OWS Phase II", and dated February of 2001. They appeared to contain soil and purge water from the contamination investigation activities at the site. Mr. Christman provided me with the name and telephone number for Mr. James Young, Olin (former property owners), at 423-336-4064. Mr. Young is the environmental manager for Olin for this site. I contacted Mr. Young on February 28, 2002 to obtain copies of the analytical data for these drums, and to inquire about their disposal plan for these drums. Mr. Young said he would check and get back to me.

Comments: A view of the two drums located on the east side of the building.
